**Flood Control Project Maintenance
Levee Inspections**

Maintenance Issue Types Only, Levee Inspection Report By Mile - Spring 2019

Reclamation District No. 0900 West Sacramento

Waterway	Bank	Unit Miles	Inspection Start/End	Inspector
Unit No. 01 Sacramento River	Right	7.70	03/26/2019 03/26/2019	Luz Dial

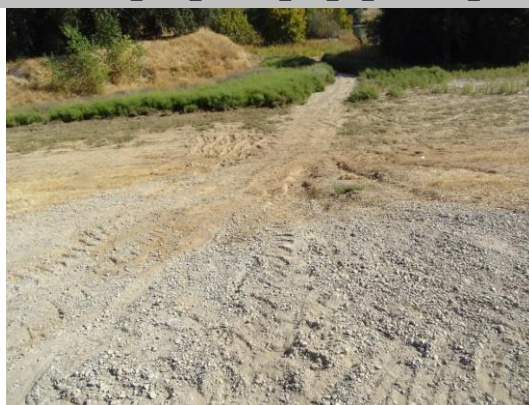
Photo 1 of 1 : SP_2019_RD0900_230_36_20190307_00008.jpg

LM Start	2.05	Rating **	A/W	Issue No.	36
LM End	2.05	Issue Type +	Ma	Location *	WS
Category	Earthen Levee			GPS Latitude/Longitude	
				Start	End
Item	Slope Stability			38.557865 °	38.557865 °
				-121.518175 °	-121.518175 °
DWR ID	DWR_RD0900_01_s_2018_36				
Comment Code					
S3 : Repair the levee slope damaged by vehicle traffic and prevent access where possible.					
Inspector Comment					
LMA repaired slope damage, but vehicles continue to access river.

View of slope damage from vehicular traffic. Fall 2018

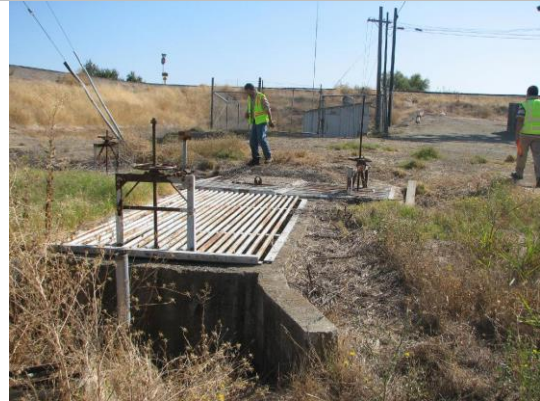
Photo 1 of 3 : UCIP_SP_2019_37668_68391.jpg

FS_ID:37668
 DS_ID:17769
 EP_NO: N/A
 Repair Type: Non-Urgent
 Crossing Status: Found
 UCIP Comments: 02/26/2018 Pipe is located within the construction limits of the Levee Improvement Project for RD0900, As-builts PENDING Project Completion. -- UNDER CONSTRUCTION Levee Improvement Project, construction schedule Summer 2016 to November 2018. Levee improvements address through seepage, underseepage and slope stability and include strengthen-in-place improvements and construction of a setback levee. Reference: [Issued FOR CONSTRUCTION] West Sacramento Area Flood Control Agency Southport Levee Improvement Project Early Implementation Program. Southport Sacramento River Levee: (Stat 3+90 to Station 287+57). Volume 3 (W.O. # 41164) December 2016 Conformed Submittal. HDR Engineering Inc. Folsom, CA – (DWR UCIP – O. Magana)
 10/06/2009 Dense vegetation limits the inspector's visibility to identify signs of pipe failure (leaks) along the slope. Recommend removing vegetation along pipe alignment to conduct proper inspection of structure and appurtenances. (DWR UCIP - O. Magana)

FIELD_STRUCT_DESC: 24-inch pipe through the levee, 22.0 feet below the crown. Pump house at the landside (LS) toe. Screw gate in LS of the levee.
 Additional Reference(s): USACE Sacramento O&M Manual Unit No. 116, August 1955, revised 2011, (USGS River Mile [RM] 55.65), As-built drawing# 6-13-1100 page 3, January 1933]
 FS Date: 10/6/2009

View of concrete structure located on landward side.

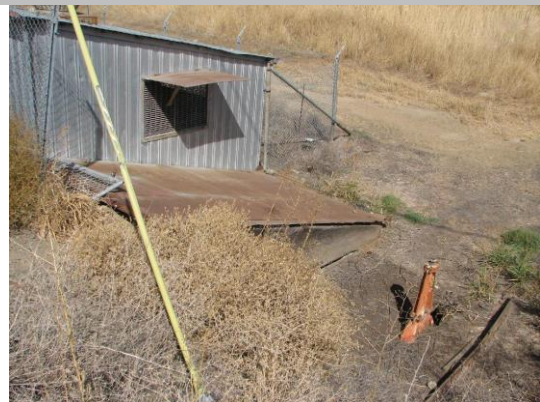
Photo 2 of 3 : UCIP_SP_2019_37668_68390.jpg

Pump house located on landward side.

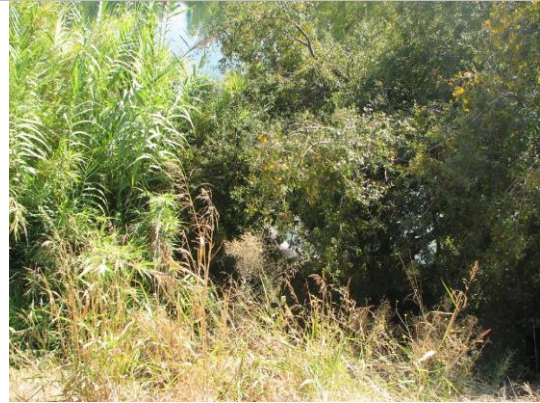
Photo 3 of 3 : UCIP_SP_2019_37668_68389.jpg

Comment Code						
Inspector Comment						
FS_ID:37668 DS_ID:17769 EP_NO: N/A Repair Type: Non-Urgent Crossing Status: Found UCIP Comments: 02/26/2018 Pipe is located within the construction limits of the Levee Improvement Project for RD0900, As-builts PENDING Project Completion. -- UNDER CONSTRUCTION Levee Improvement Project, construction schedule Summer 2016 to November 2018. Levee improvements address through seepage, underseepage and slope stability and include strengthen-in-place improvements and construction of a setback levee. Reference: [Issued FOR CONSTRUCTION] West Sacramento Area Flood Control Agency Southport Levee Improvement Project Early Implementation Program. Southport Sacramento River Levee: (Stat 3+90 to Station 287+57). Volume 3 (W.O. # 41164) December 2016 Conformed Submittal. HDR Engineering Inc. Folsom, CA – (DWR UCIP – O. Magana) 10/06/2009 Dense vegetation limits the inspector's visibility to identify signs of pipe failure (leaks) along the slope. Recommend removing vegetation along pipe alignment to conduct proper inspection of structure and appurtenances. (DWR UCIP - O. Magana) FIELD_STRUCT_DESC: 24-inch pipe through the levee, 22.0 feet below the crown. Pump house at the landside (LS) toe. Screw gate in LS of the levee. Additional Reference(s): USACE Sacramento O&M Manual Unit No. 116, August 1955, revised 2011, (USGS River Mile [RM] 55.65), As-built drawing# 6-13-1100 page 3, January 1933] FS Date: 10/6/2009

Pipe visible on waterward side visible through dense vegetation.

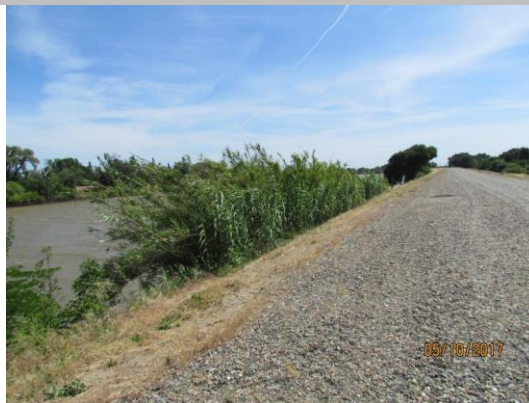
Photo 1 of 1 : SP_2019_RD0900_230_59_20190307_00012.jpg

LM Start	7.47	Rating **	A/W	Issue No.	59
LM End	7.47	Issue Type +	Ma	Location *	WS
Category	Earthen Levee			GPS Latitude/Longitude	
				Start	End
Item	Vegetation			38.507648 °	38.507648 °
				-121.557571 °	-121.557571 °
DWR ID	DWR_RD0900_01_f_2012_59				
Comment Code					
V2 : Remove the wild growth other than native grasses from the levee slopes.					
Inspector Comment					
LMA sprayed Arundo on the waterside slope of the levee, but vegetation needs to be removed.

View of the arundo on the waterside of the levee during spring 2017 inspection.

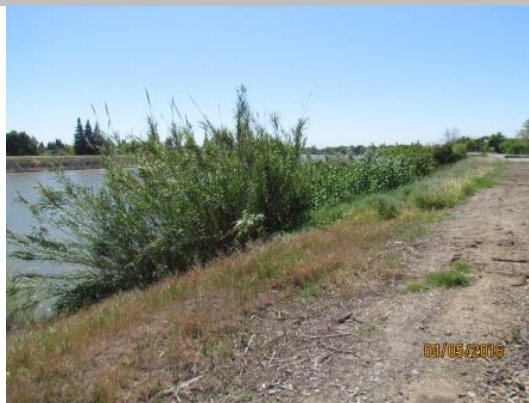
Photo 1 of 2 : SP_2019_RD0900_230_15_20190307_00003.jpg

LM Start	7.78	Rating **	A/W	Issue No.	15
LM End	7.78	Issue Type +	Ma	Location *	WS
Category	Earthen Levee			GPS Latitude/Longitude	
				Start	End
Item	Vegetation			38.503490 °	38.503490 °
				-121.559770 °	-121.559770 °
DWR ID	DWR_RD0900_01_f_2013_15				
Comment Code					
V2 : Remove the wild growth other than native grasses from the levee slopes.					
Inspector Comment					
LMA sprayed Arundo on the waterside, but dead vegetation needs to be removed.

Picture of the arundo on the waterside of the levee during spring 2016 inspection.

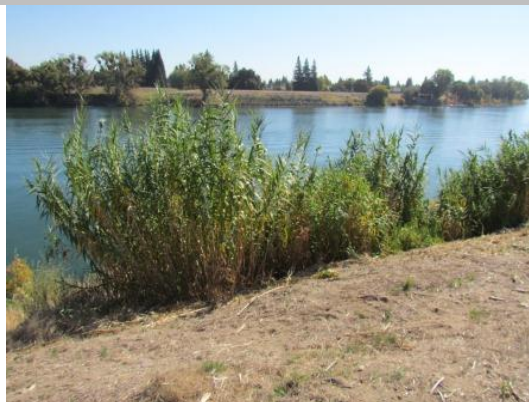
Photo 2 of 2 : SP_2019_RD0900_230_15_20190307_00004.jpg

View of arundo on the waterside of the levee looking downstream.

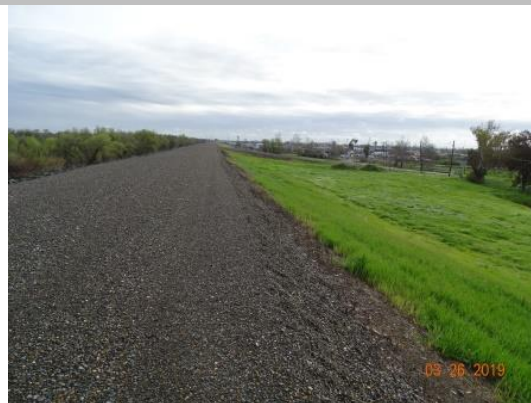
Photo 1 of 1 : SP_2019_RD0900_231_41_20190327_00051.jpg

LM Start	0.00	Rating **	A	Issue No.	41
LM End	0.87	Issue Type +	Ma	Location *	LS
Category	Earthen Levee			GPS Latitude/Longitude	
				Start	End
Item	Vegetation			38.582085 °	38.574708 °
				-121.567899 °	-121.580222 °
DWR ID	DWR_RD0900_02_s_2019_41				
Comment Code					
V1 : Control annual grass and weeds on the levee slopes and easements.					
Inspector Comment					
Annual vegetation is well-maintained.

View of well-maintained landside vegetation. Spring 2019

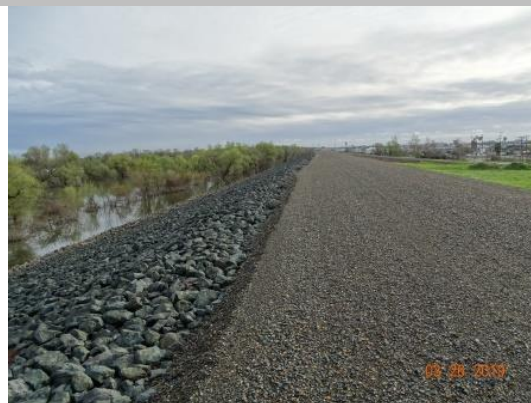
Photo 1 of 1 : SP_2019_RD0900_231_42_20190327_00052.jpg

LM Start	0.00	Rating **	A	Issue No.	42
LM End	0.87	Issue Type +	Ma	Location *	WS
Category	Earthen Levee			GPS Latitude/Longitude	
				Start	End
Item	Vegetation			38.582085 °	38.574708 °
				-121.567899 °	-121.580222 °
DWR ID	DWR_RD0900_02_s_2019_42				
Comment Code					
V1 : Control annual grass and weeds on the levee slopes and easements.					
Inspector Comment					
Annual vegetation is well-maintained.

View of well-maintained waterside vegetation. Spring 2019

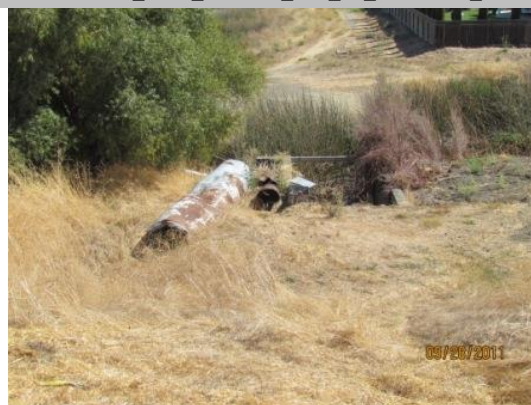
Photo 1 of 1 : SP_2019_RD0900_231_15_20190307_00002.jpg

LM Start	3.26	Rating **	M	Issue No.	15
LM End	3.26	Issue Type +	Ma	Location *	LS
Category	Earthen Levee			GPS Latitude/Longitude	
				Start	End
Item	Encroachments			38.540943 °	38.540943 °
				-121.582280 °	-121.582280 °
DWR ID	DWR_RD0900_02_s_2012_15				
Comment Code					
PI : Pipe					
Inspector Comment					
Abandoned pipe still remains on the levee slope.

Abandoned pipes and debris were found on the landside of the levee looking upstream.

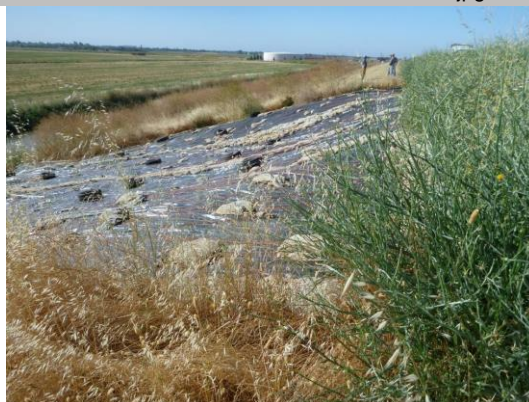
Photo 2 of 8 : LEVAL SP 2019 198 189.jpg

Comment Code					
Inspector Comment					
Levee Evaluation Comments					
Description:					
Site ID No:198					
Site Designation:RD 900-01					
Repair Type: Erosion					
Rating:Serious					
Field Date:6/6/2017					
Notes: LS, thorny vegetation is present at levee toe/canal. Light grass present along LS slope. Primary use of canal is for drainage, ranges in width 15-25; on average 20ft. RD rep. mentioned permitting has begun to replace drainage canal with 32in pipe for storm drainage to community. 8,600 LF of the LS levee has sloughing of the LS toe access road into drainage canal. There is no imminent threat of losing levee in next storm event. DWR inspector: LMA repaired two landside erosion sites (levee mile 5.26 and 4.63) during fall 2017 inspection.

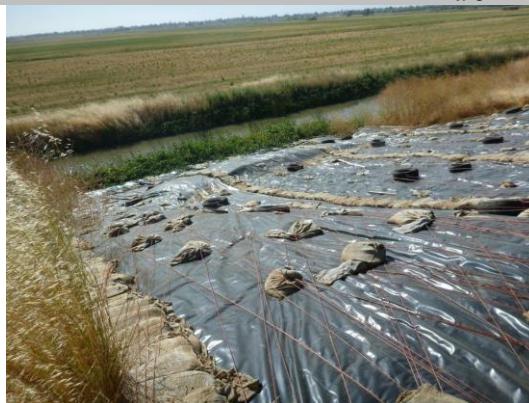
Photo 3 of 8 : LEVAL_SP_2019_198_190.jpg

Comment Code						
Inspector Comment						
Levee Evaluation Comments						
Description:						
Site ID No:198						
Site Designation:RD 900-01						
Repair Type: Erosion						
Rating:Serious						
Field Date:6/6/2017						
Notes: LS, thorny vegetation is present at levee toe/canal. Light grass present along LS slope. Primary use of canal is for drainage, ranges in width 15-25; on average 20ft. RD rep. mentioned permitting has begun to replace drainage canal with 32in pipe for storm drainage to community. 8,600 LF of the LS levee has sloughing of the LS toe access road into drainage canal. There is no imminent threat of losing levee in next storm event. DWR inspector: LMA repaired two landside erosion sites (levee mile 5.26 and 4.63) during fall 2017 inspection.

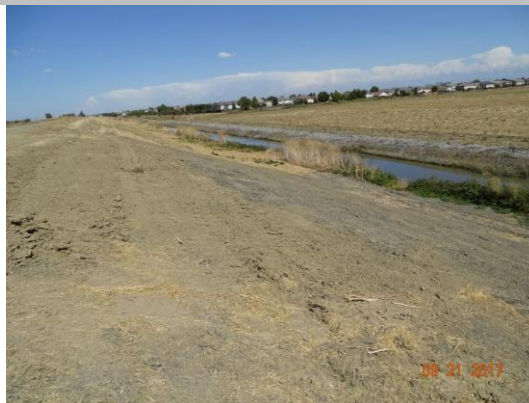
Photo 7 of 8 : SP_2019_RD0900_231_40_20190307_00010.jpg

Comment Code					
Inspector Comment					
Levee Evaluation Comments					
Description:					
Site ID No:198					
Site Designation:RD 900-01					
Repair Type: Erosion					
Rating:Serious					
Field Date:6/6/2017					
Notes: LS, thorny vegetation is present at levee toe/canal. Light grass present along LS slope. Primary use of canal is for drainage, ranges in width 15-25; on average 20ft. RD rep. mentioned permitting has begun to replace drainage canal with 32in pipe for storm drainage to community. 8,600 LF of the LS levee has sloughing of the LS toe access road into drainage canal. There is no imminent threat of losing levee in next storm event. DWR inspector: LMA repaired two landside erosion sites (levee mile 5.26 and 4.63) during fall 2017 inspection.

View of a repaired slope instability site on the landside of the levee looking upstream on levee mile 4.63 (38.52111, -121.582148). Fall 2017

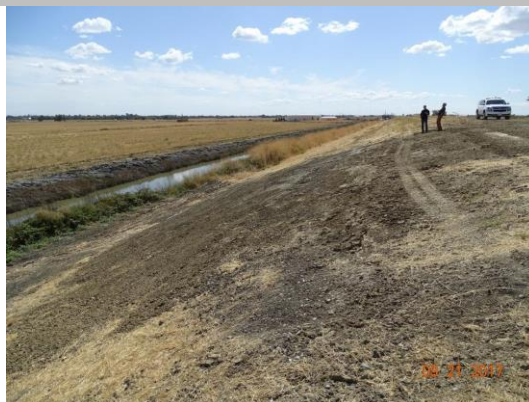
Photo 8 of 8 : SP_2019_RD0900_231_40_20190307_00011.jpg

View of a repaired slope instability site on the landside of the levee looking downstream on levee mile 4.63 (38.52111, -121.582148). Fall 2017

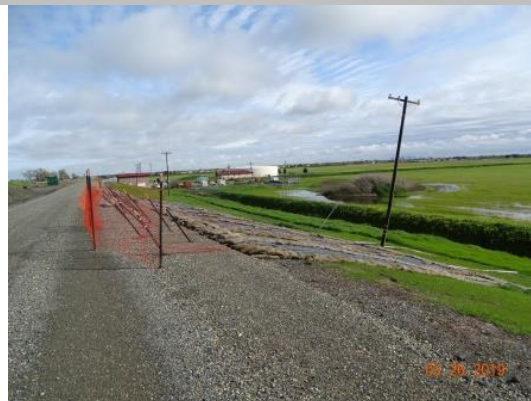
Photo 1 of 2 : SP_2019_RD0900_231_54_20190327_00057.jpg

LM Start	5.10	Rating **	U	Issue No.	54
LM End	5.10	Issue Type +	Ma	Location *	LS
Category	Earthen Levee			GPS Latitude/Longitude	
				Start	End
Item	Slope Stability			38.514278 °	38.514278 °
				-121.582192 °	-121.582192 °
DWR ID	DWR_RD0900_02_s_2019_54				
Comment Code					
S1 : Repair slope instability.					
Inspector Comment					
LMA mitigated 80' of a slip on the landside slope but needs to repair it in the dry season.

View looking north at ~80' landside slip that LMA mitigated. Spring 2019

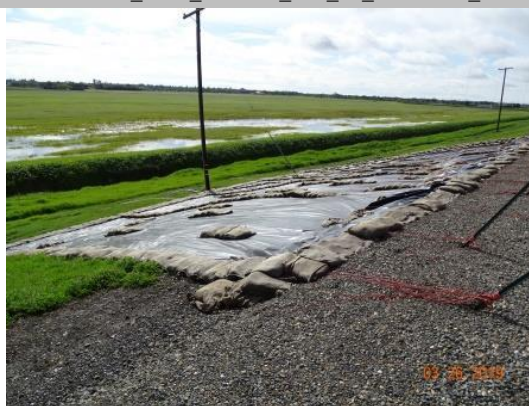
Photo 2 of 2 : SP_2019_RD0900_231_54_20190327_00058.jpg

LM Start	5.10	Rating **	U	Issue No.	54 (cont)	
LM End	5.10	Issue Type +	Ma	Location *	LS	
Category	Earthen Levee			GPS Latitude/Longitude		
				Start		End
Item	Slope Stability			38.514278 °		38.514278 °
				-121.582192 °		-121.582192 °
DWR ID	DWR_RD0900_02_s_2019_54					
Comment Code						
S1 : Repair slope instability.						
Inspector Comment						
LMA mitigated 80' of a slip on the landside slope but needs to repair it in the dry season.

View looking southeast at ~80' landside slip that LMA mitigated. Spring 2019

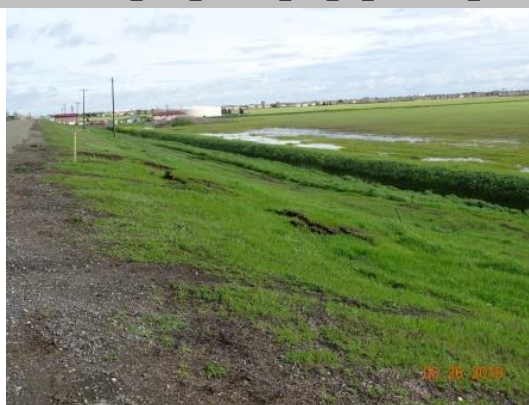
Photo 1 of 2 : SP_2019_RD0900_231_55_20190327_00054.jpg

LM Start	5.24	Rating **	U	Issue No.	55
LM End	5.26	Issue Type +	Ma	Location *	LS
Category	Earthen Levee			GPS Latitude/Longitude	
				Start	End
Item	Slope Stability			38.512212 °	38.511930 °
				-121.582177 °	-121.582187 °
DWR ID	DWR_RD0900_02_s_2019_55				
Comment Code					
S1 : Repair slope instability.					
Inspector Comment					
Repair slip that is ~100' long and 2-3' deep.

View looking northward at 100'-long slip that is roughly 2-3' deep. Spring 2019

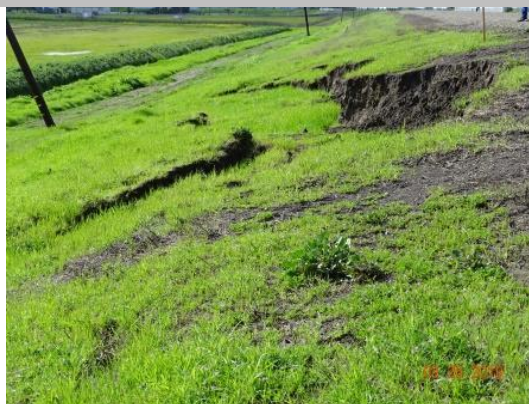
Photo 2 of 2 : SP_2019_RD0900_231_55_20190327_00056.jpg

View looking southward at 100'-long slip that is roughly 2-3' deep. Spring 2019

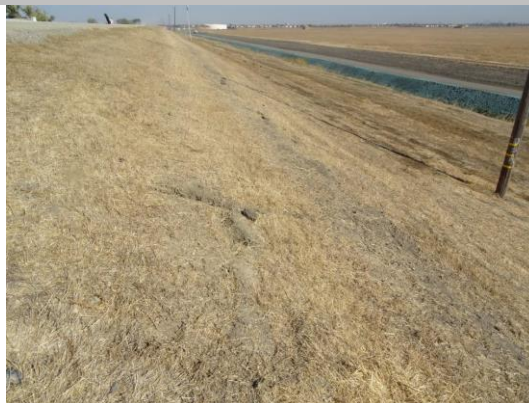
Photo 1 of 1 : SP_2019_RD0900_231_27_20190307_00003.jpg

LM Start	5.45	Rating **	A/W	Issue No.	27
LM End	5.45	Issue Type +	Ma	Location *	LS
Category	Earthen Levee			GPS Latitude/Longitude	
				Start	End
Item	Slope Stability			38.509217 °	38.509217 °
				-121.582140 °	-121.582140 °
DWR ID	DWR_RD0900_02_f_2018_27				
Comment Code					
S1 : Repair slope instability.					
Inspector Comment					
Monitor area for desiccation cracks on the levee slope.

View of desiccation cracks on levee. Fall 2018
